Infrared Thermography and The Building Envelope

Regardless of the building type involved, infrared thermography can provide remarkable nondestructive information about construction details and building performance.

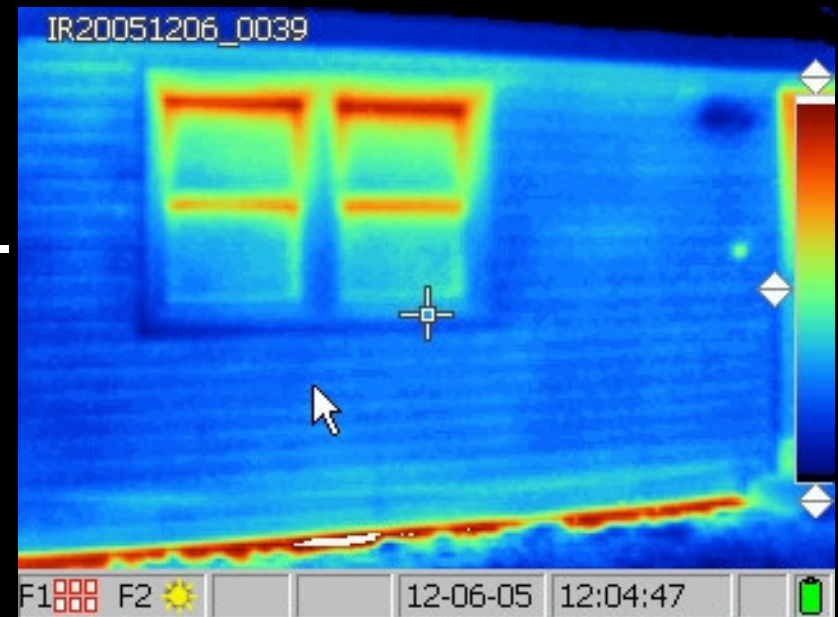
The higher the temperature the brighter the object becomes. Note the high amount of heat loss from the building foundation

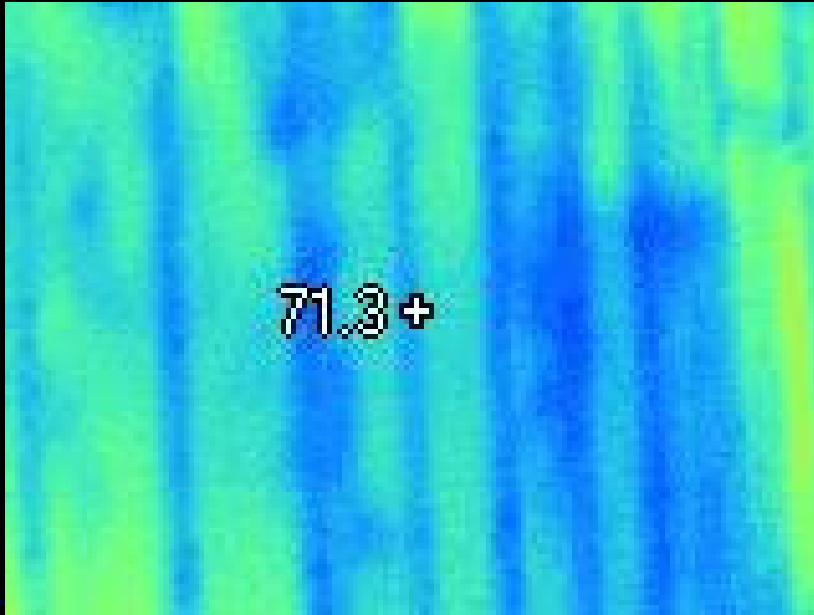
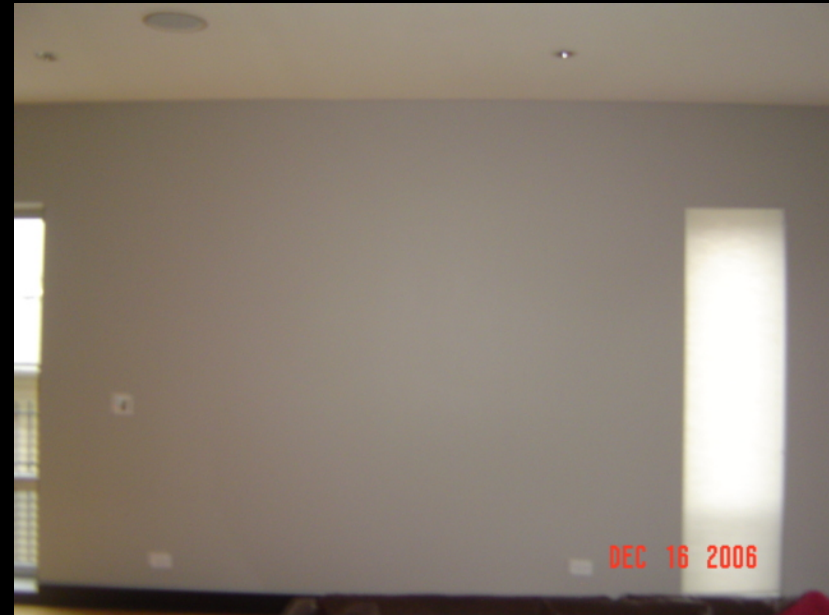
Missing Insulation

When conditions are right, it is possible to locate missing, damaged or wet insulation, such as this area behind an interior wall

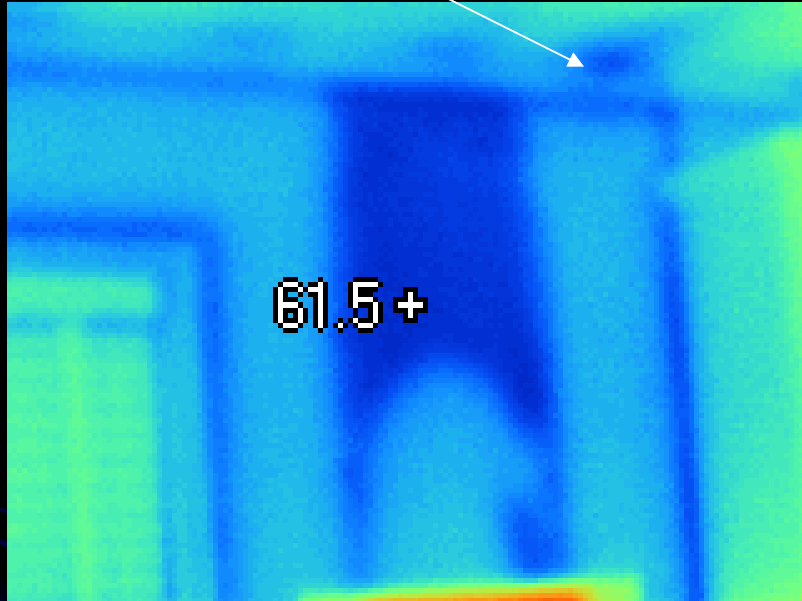
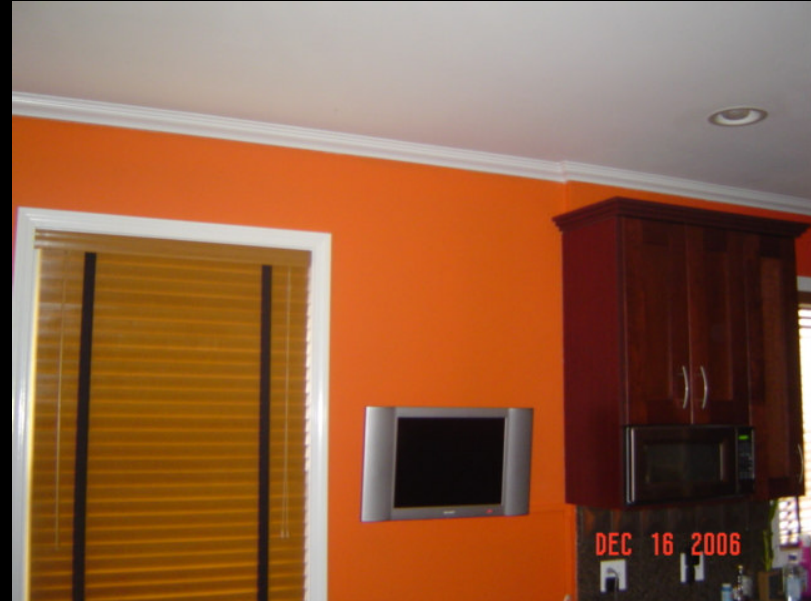
Wall Insulation

Missing insulation is easily found in this image. Note the cold air infiltrating into the ceiling

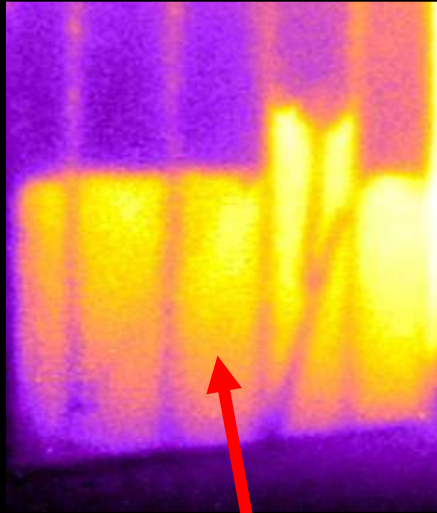
Exterior stucco wall was repaired/replaced. The insulation was removed and not replaced.

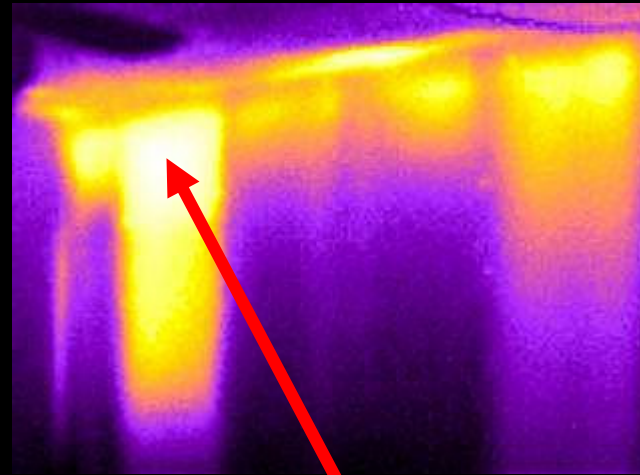
Interior view of exterior wall. Insulation is degraded possibly from previous roof leaks. Most severe at arrow tip.

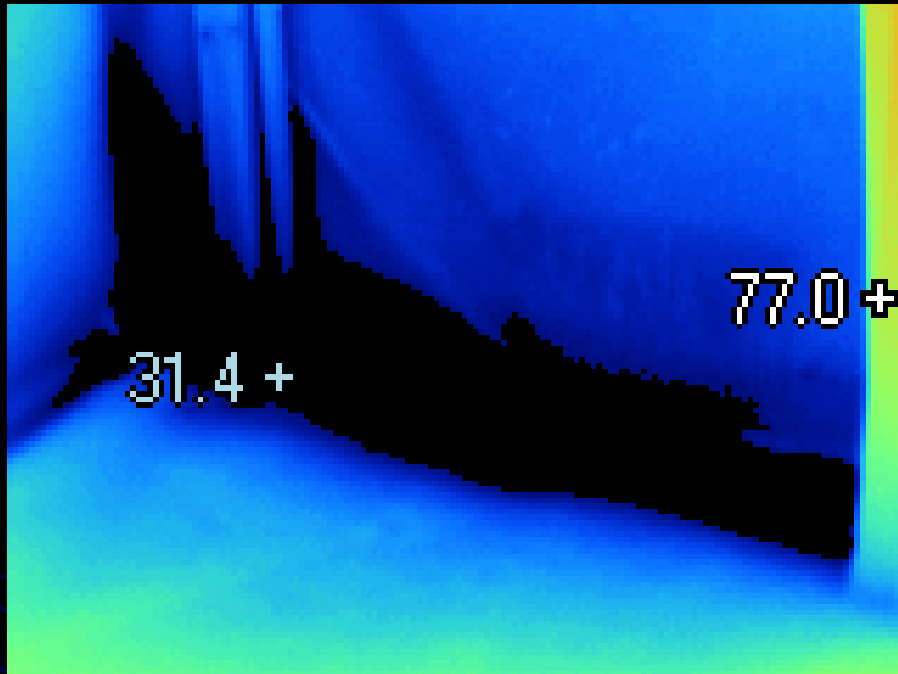
Air Leakage Location

This image is of a sliding glass door. The corner at the adjacent wall was not insulated and there was poor weather seals on the door. This excessive cold caused condensation and subsequently mold to form in the corner. Note the temperature difference between the wall 77 f and the bottom of the door 31.4 f.

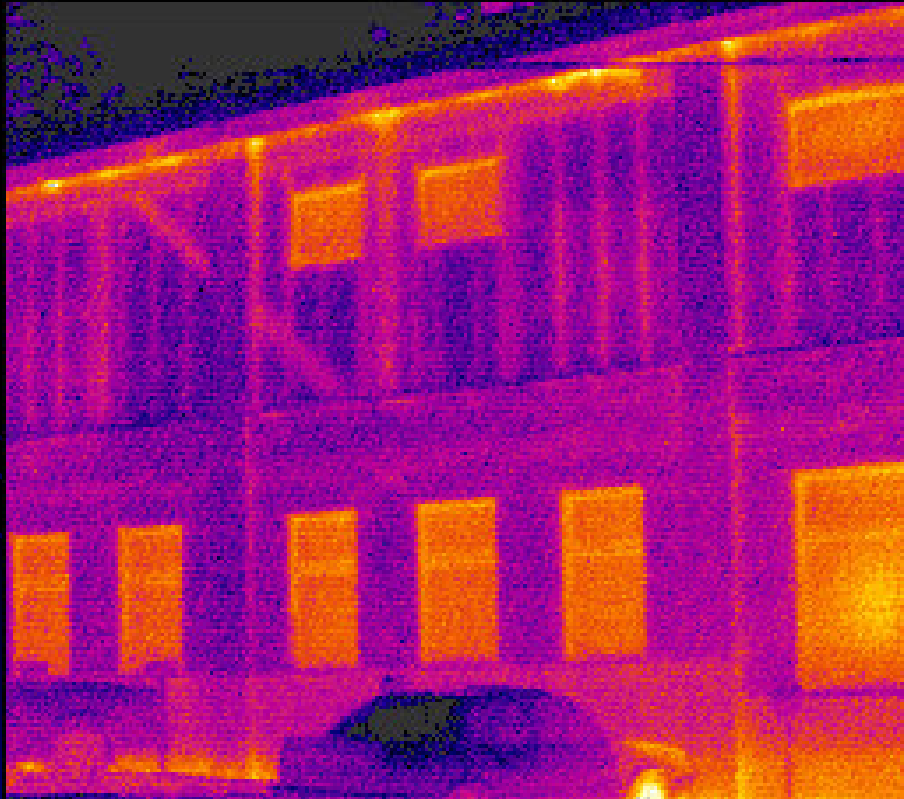
New Construction

All the framing and insulation is clearly visible in this commercial building.

Normal pressure differences on the top floor result in air leaking past the envelope through various pathways.

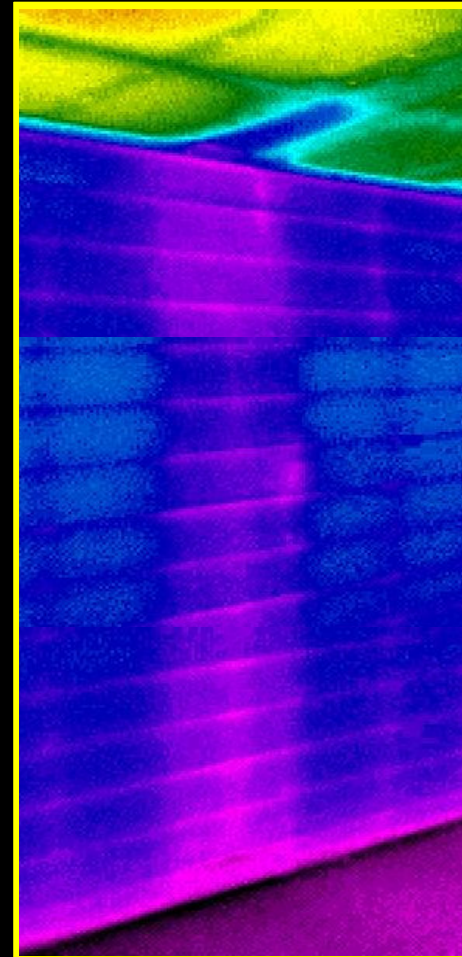
Leak from roof
and down the wall

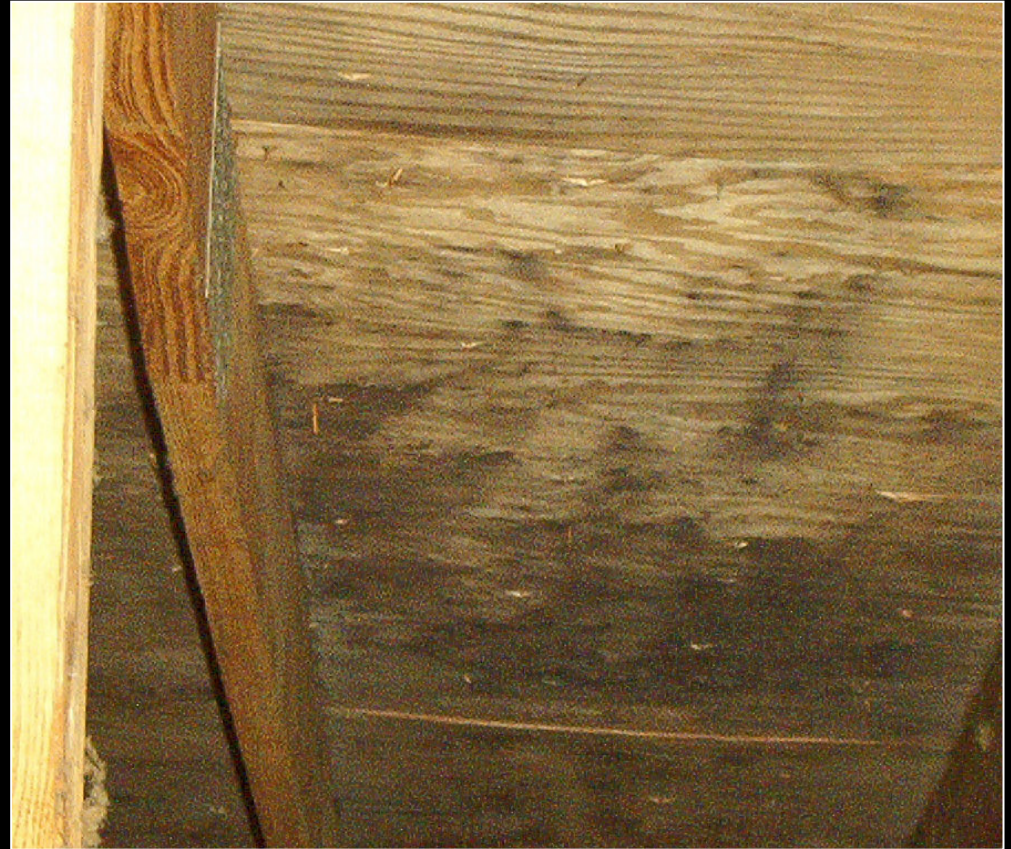
Condensation and Mold

This mold was caused by condensation on the sheathing.

There was a utility room with a hatch to access the attic. In the room was a washer and dryer, wash tub, furnace and humidifier.

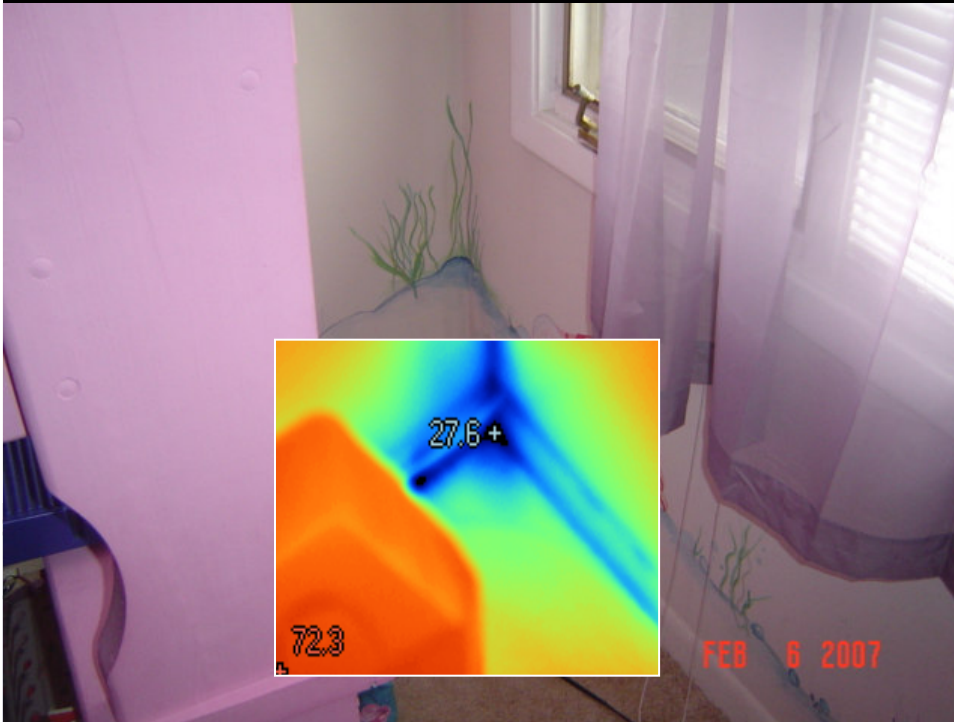
Cold outside air and humid indoor air have caused condensation in this baby's room.

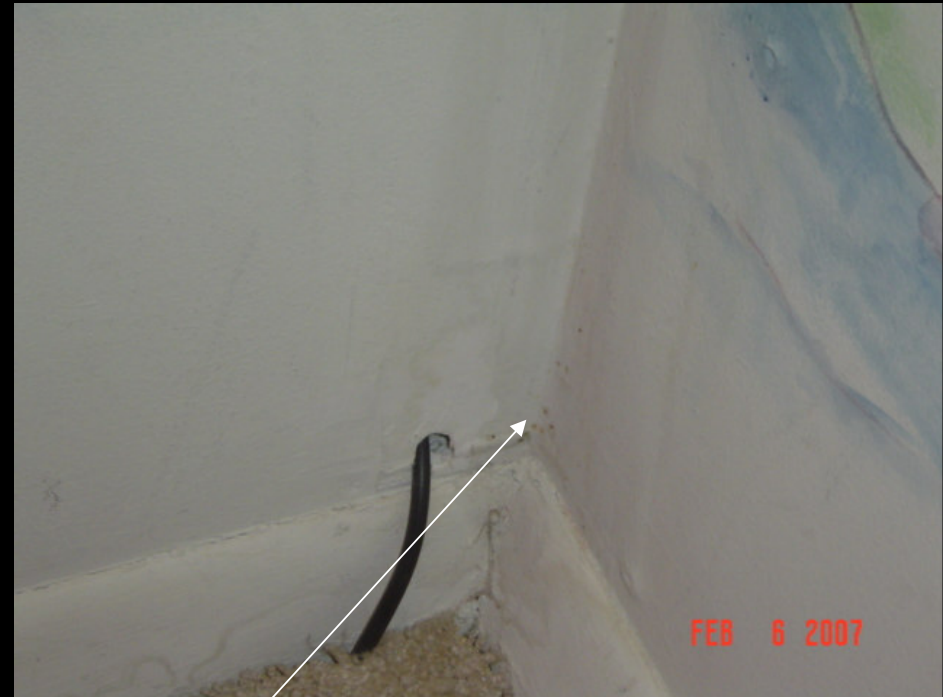
This condensation has caused active mold growth.

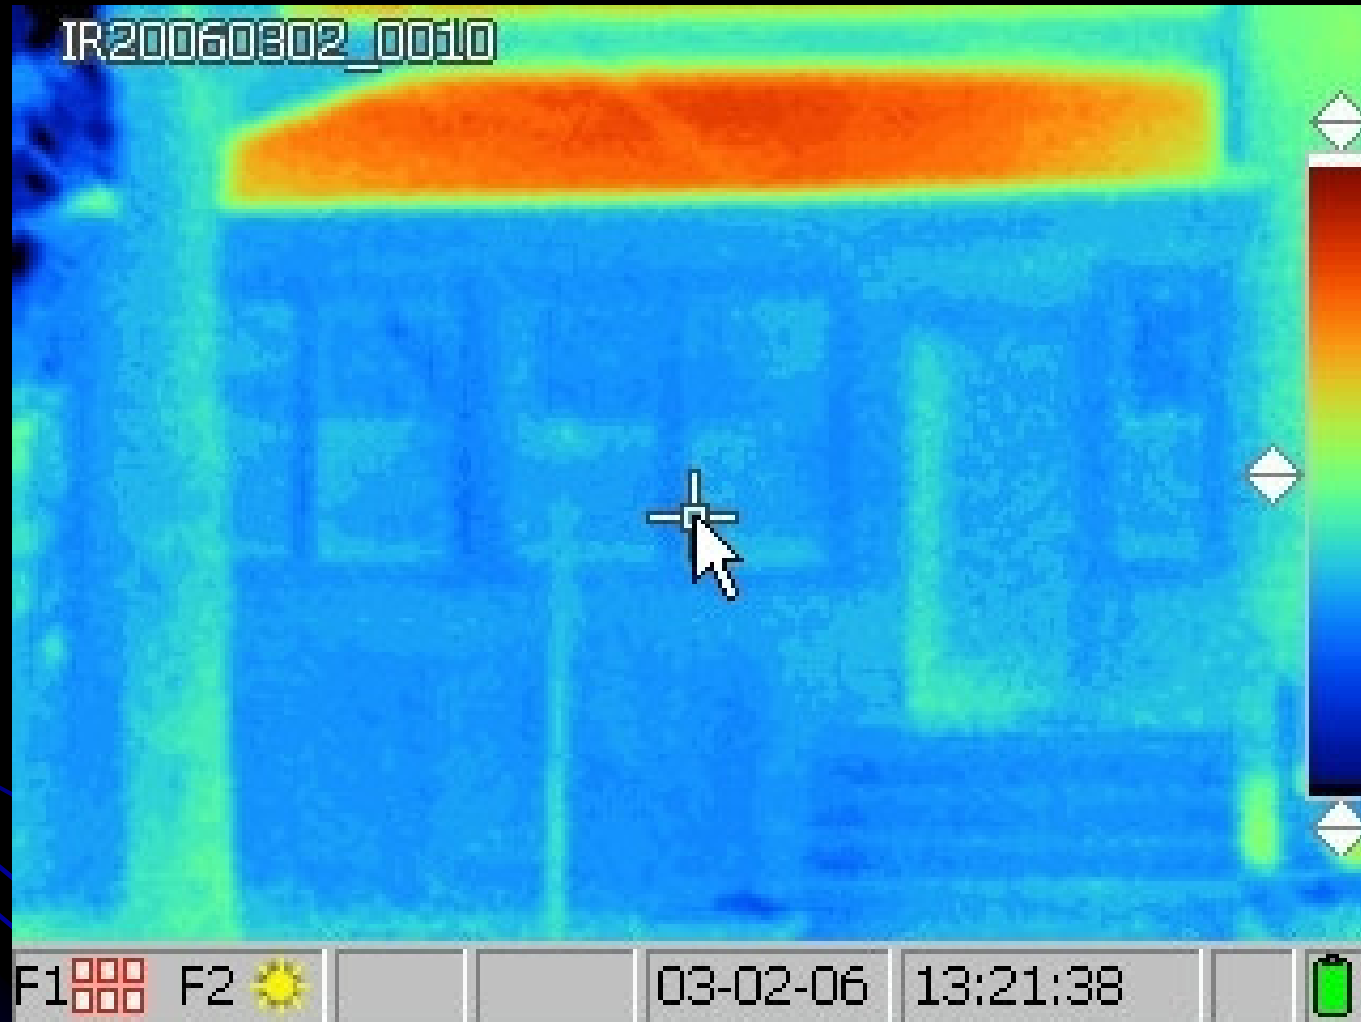
View shows a lack of insulation over this dining area

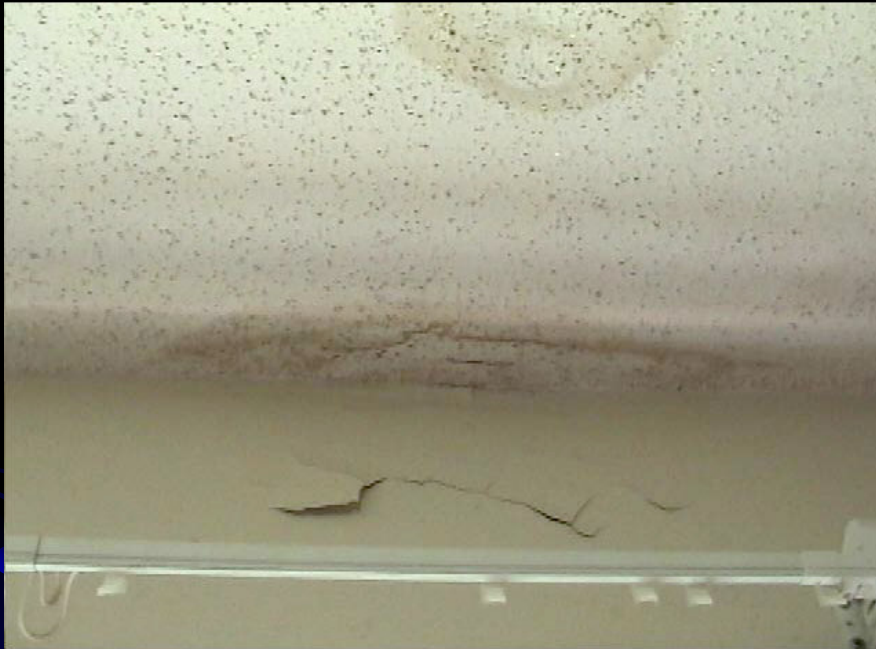
Ceiling and drywall damage

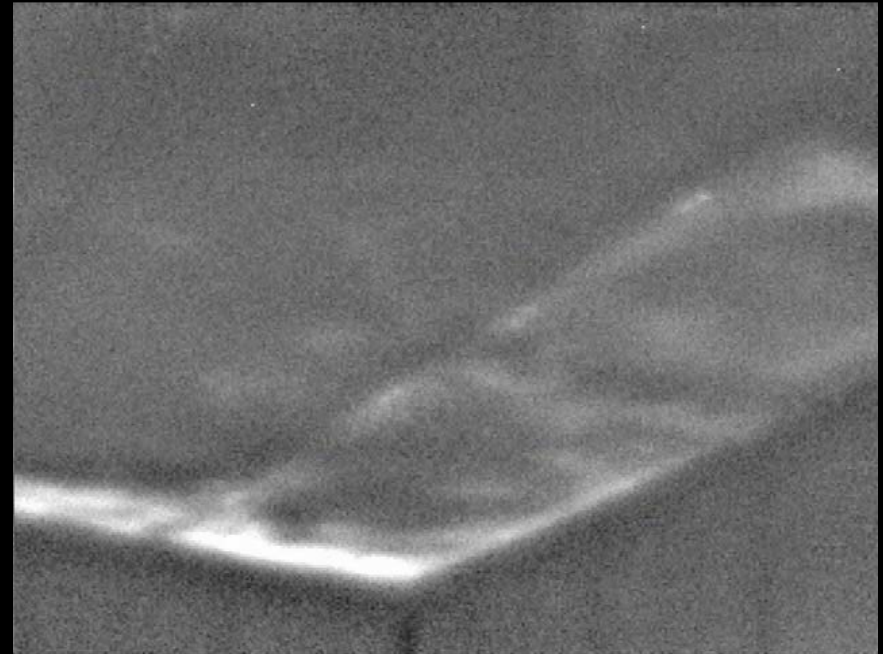
Condensation where insulation was disrupted

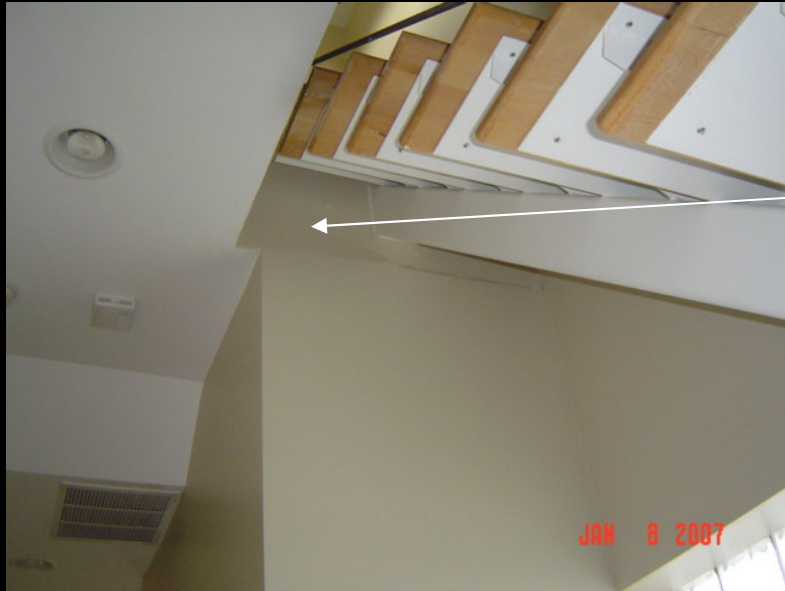
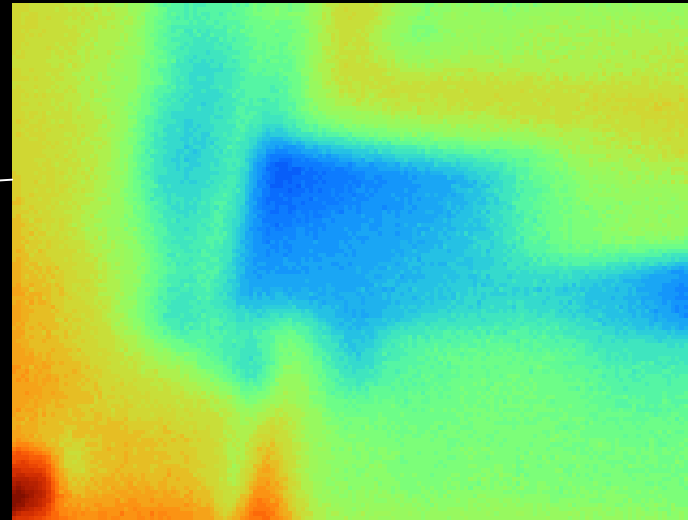
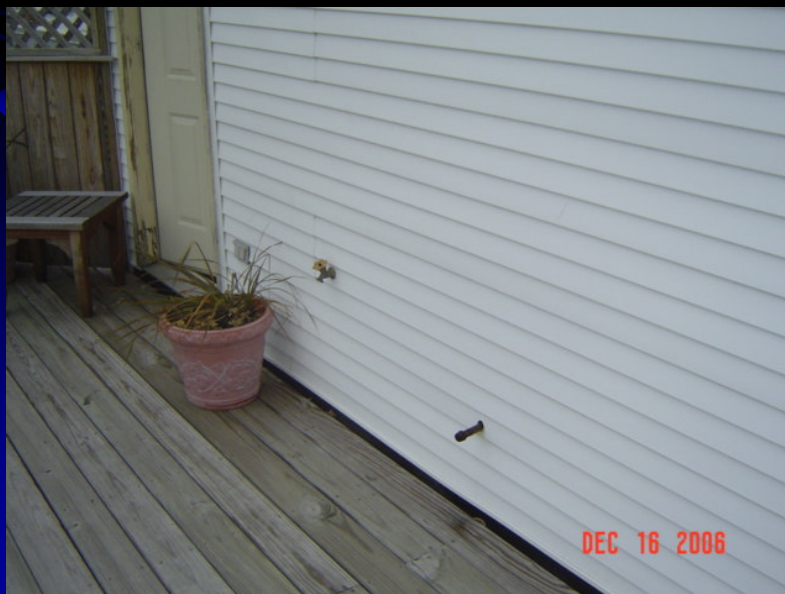
Detection and Cause of a Roof Leak

Leaks were caused by penetrations of the siding that were not sealed. Gas pipe and water spigot.

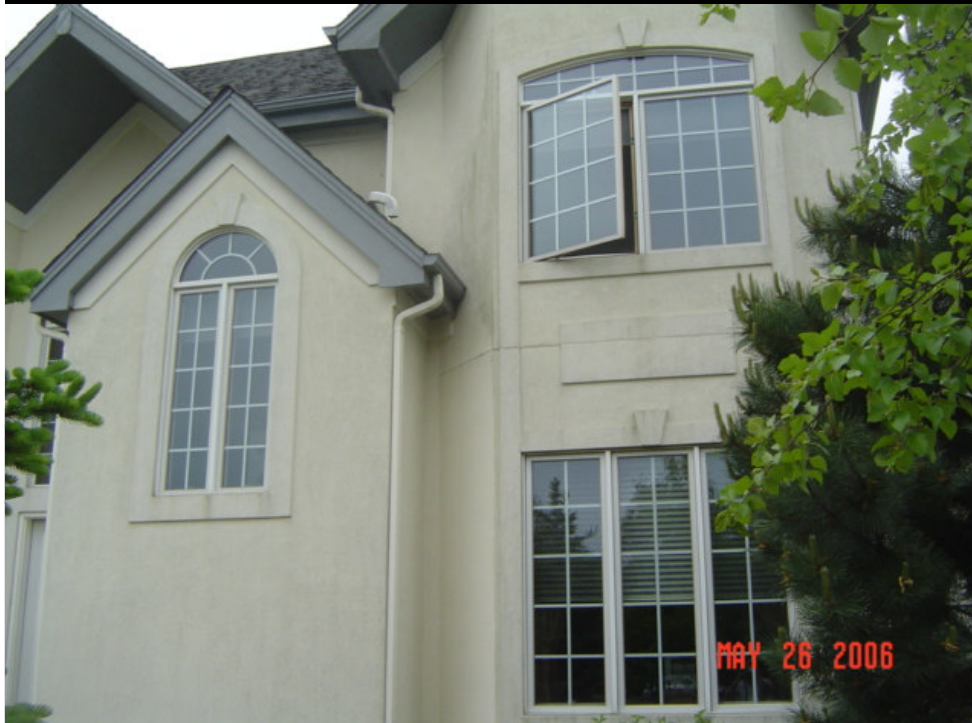
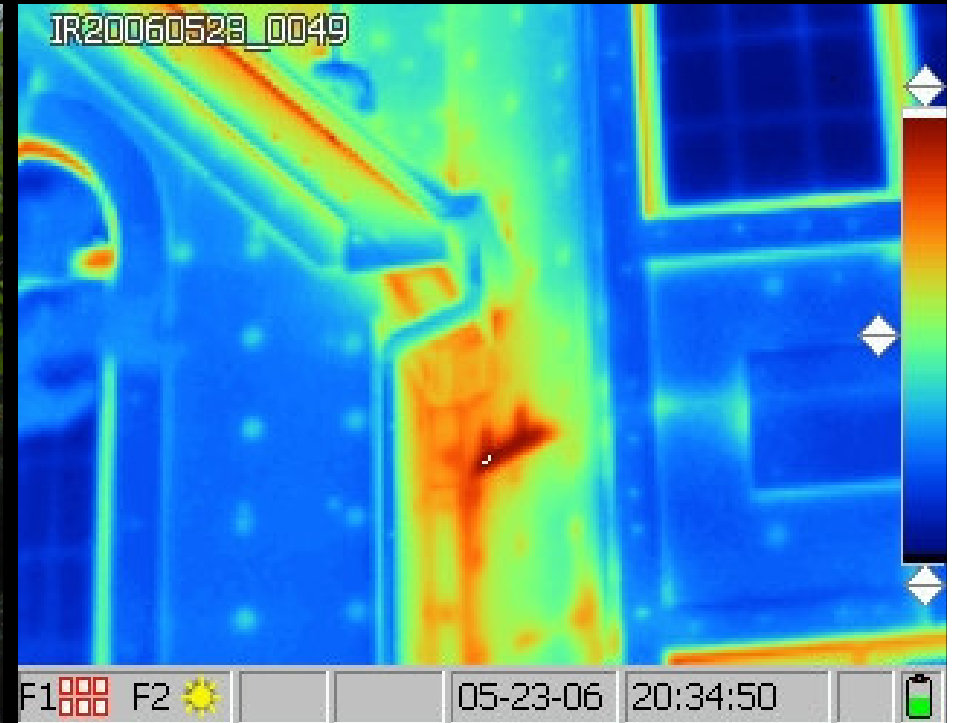
EIFS

POOR DETAIL WORK HAS ALLOWED WATER TO ENTER THIS WALL SYSTEM

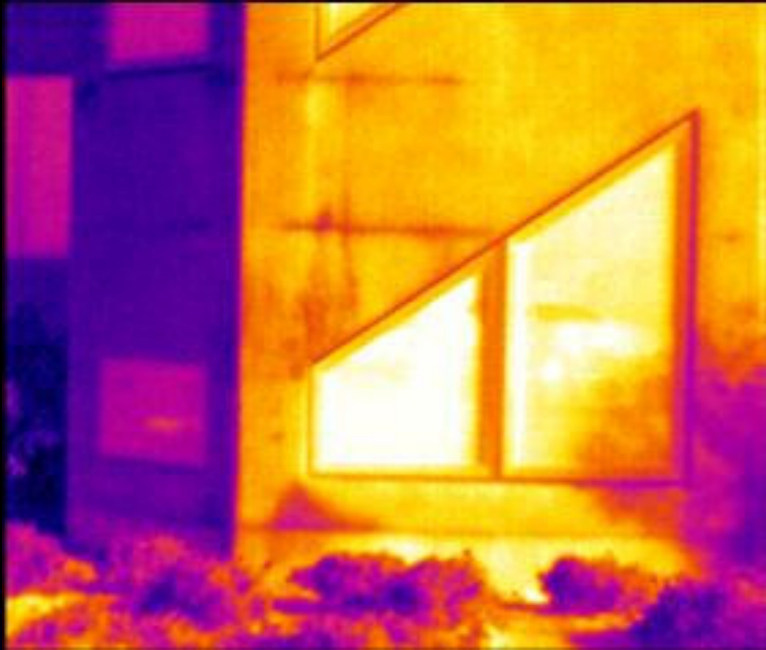
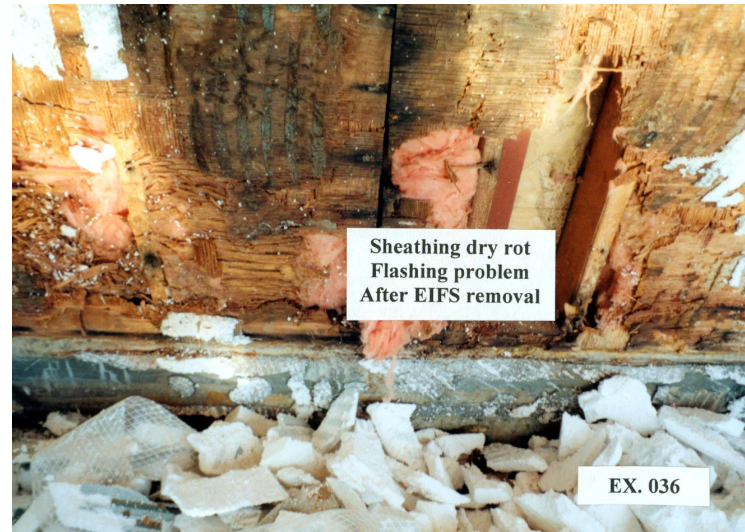
EIFS AND MOLD

The growing popularity to use EIFS on structures has been accompanied by numerous cases of moisture related structural damage. Although some of the cases are due to leaks around windows and doors, others are caused by poor installation of drainage systems.

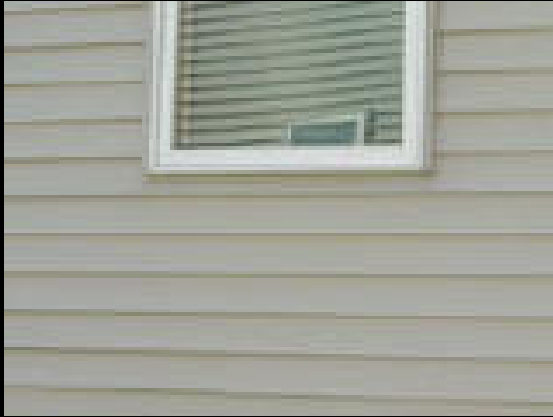
Suspect wall

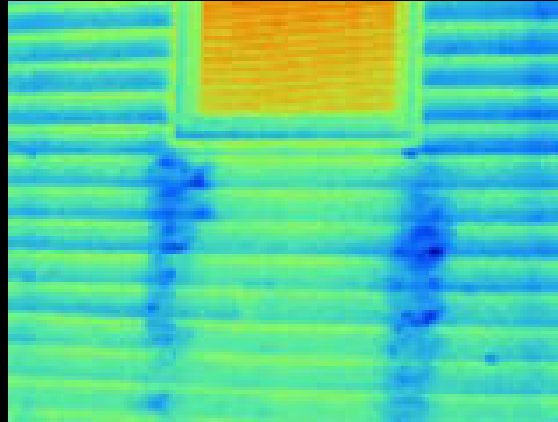
Image consistent with water damage

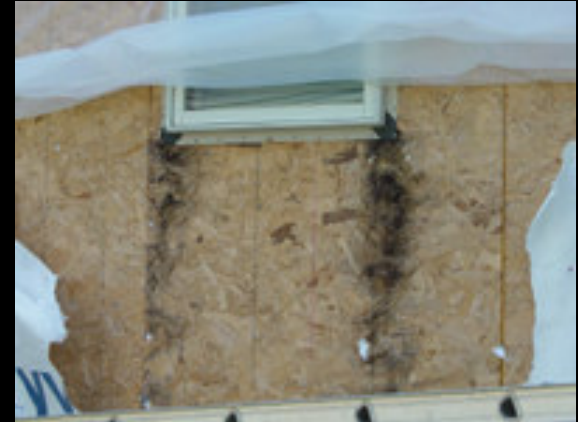
Fungal contamination and rot

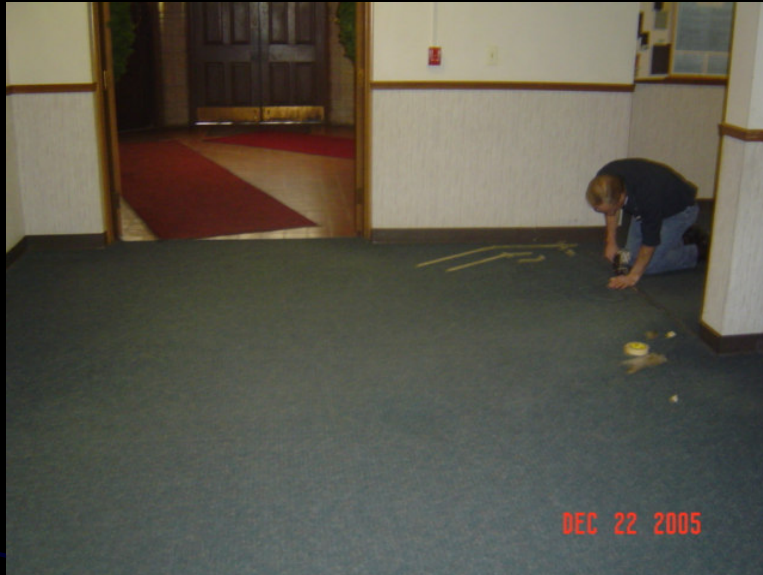
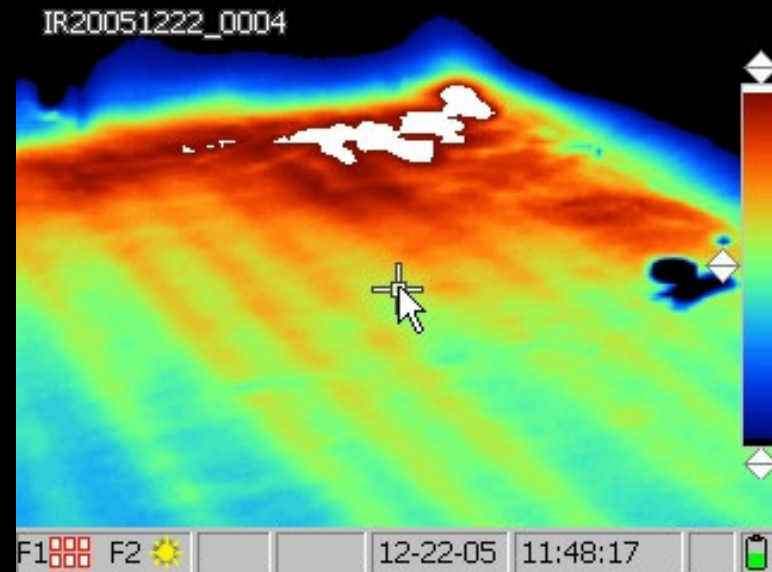
Subsurface Heat Sources

Thermography easily identifies locations and deficiencies in subsurface piping.

Here the exact location of a leak allowed the technician to concentrate his destructive work to a small area instead of destroying large sections to find the broken pipe.

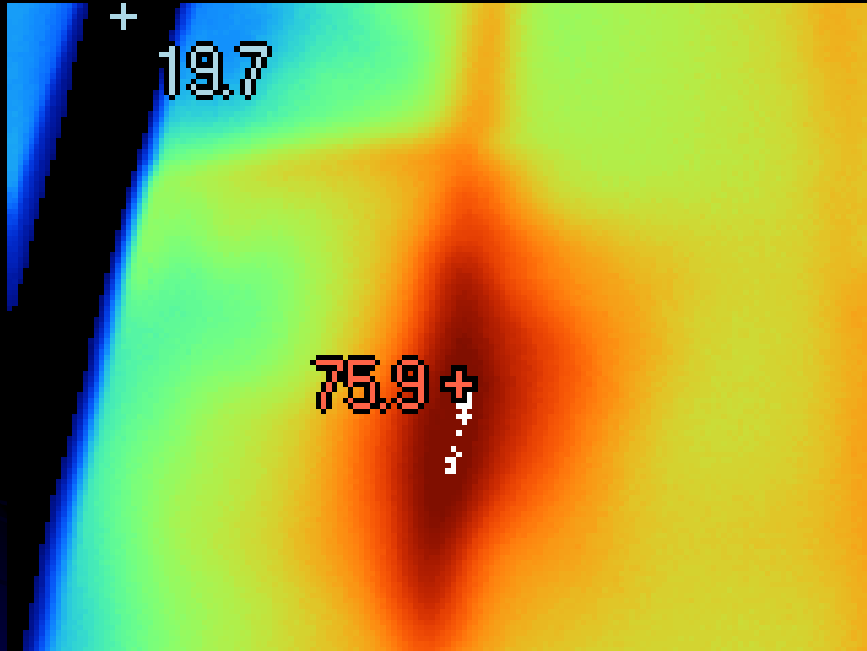
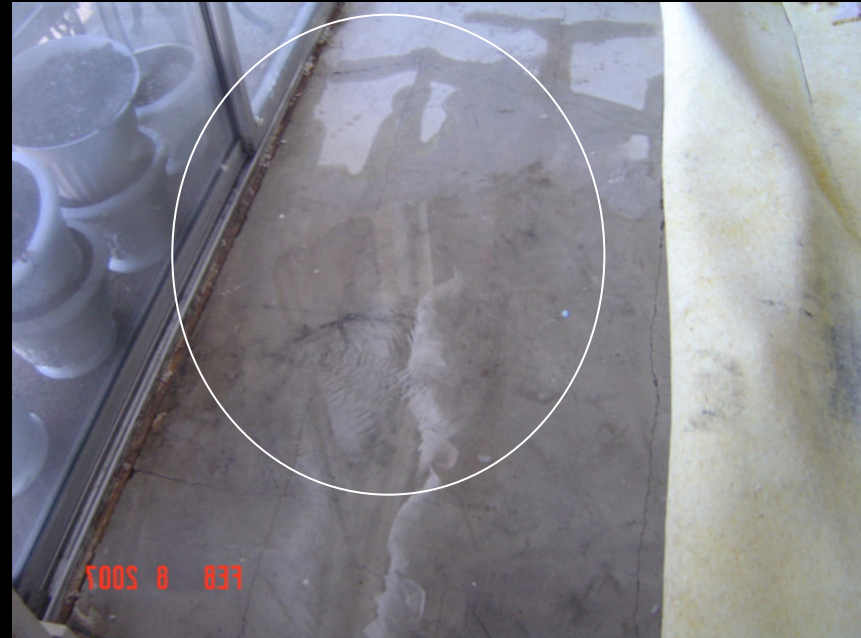
Broken Heat Pipes

Cold air from this patio door caused the pipes to freeze and burst. Severe damage was done to this unit and the unit below.

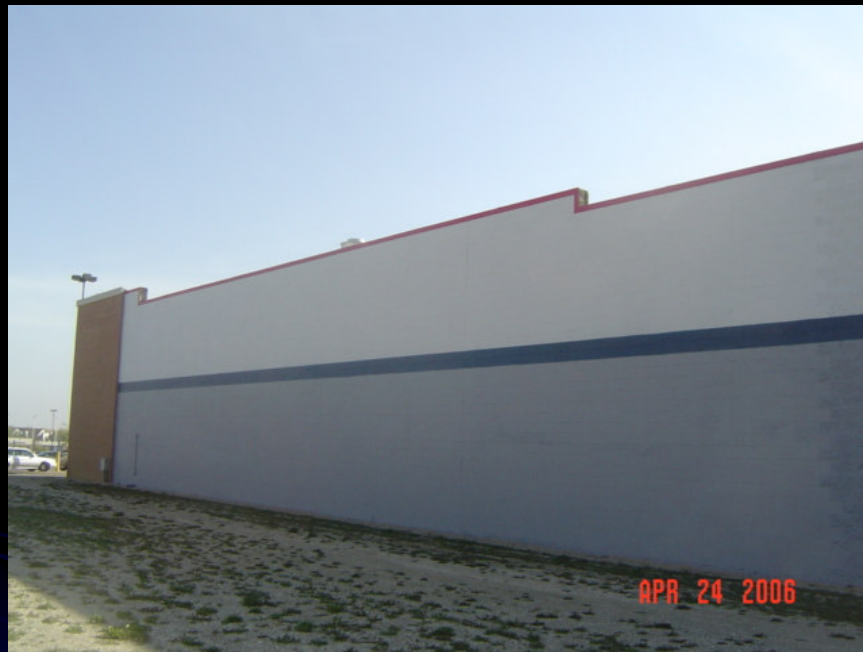
Painted Concrete Block Wall

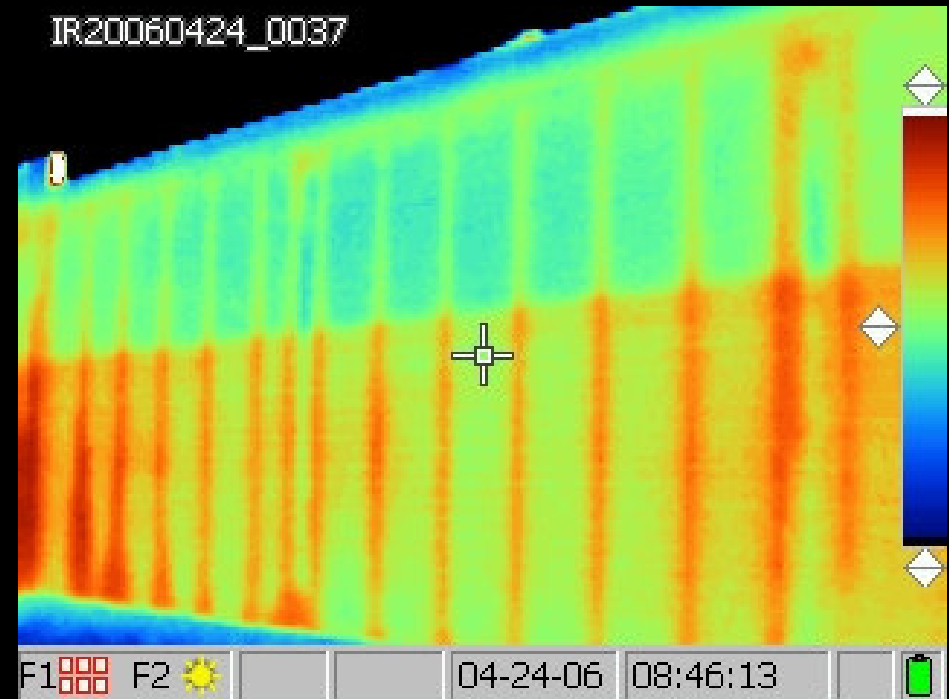
Grouted Cells Filled At Regular Intervals

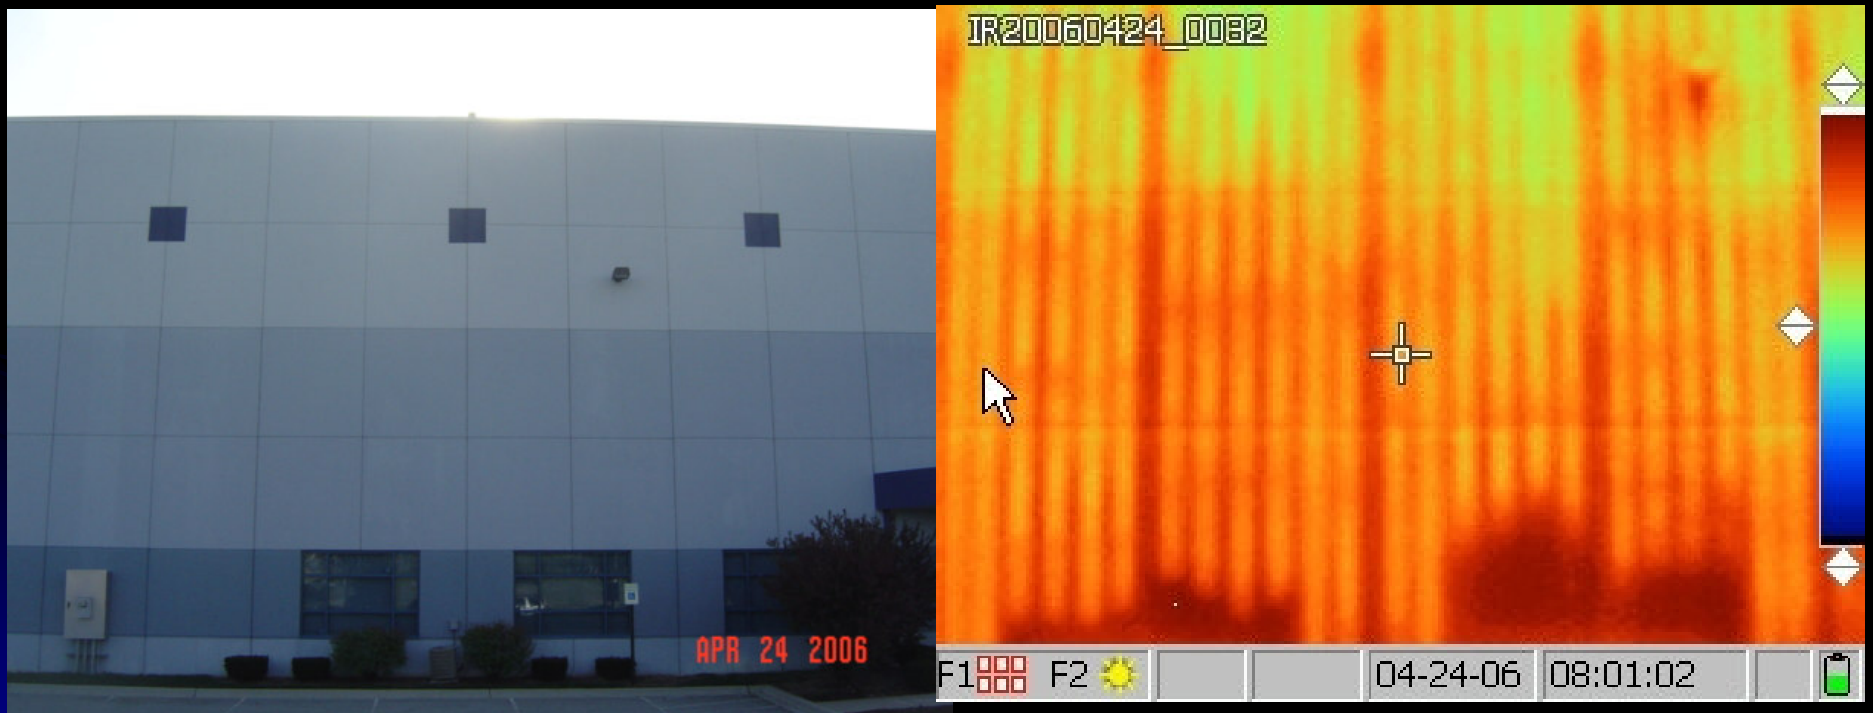
Popular Precast Concrete Wall

Photo shows distinct lines of the cables in the precast masonry wall

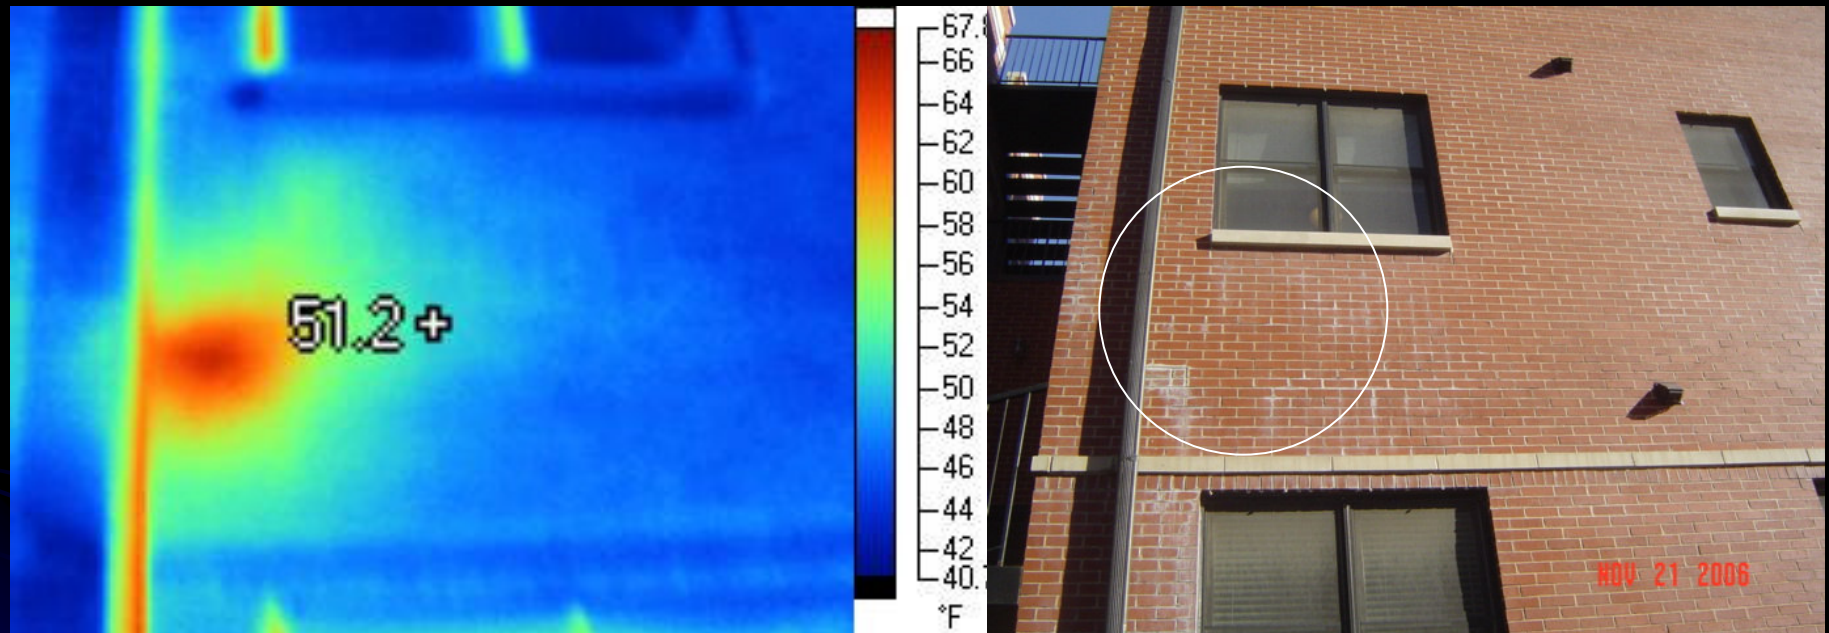
This interesting image detected a heat source in a repaired brick wall. The source of the heat was a vent pipe for a clothes dryer bricked in and blocked in the wall.

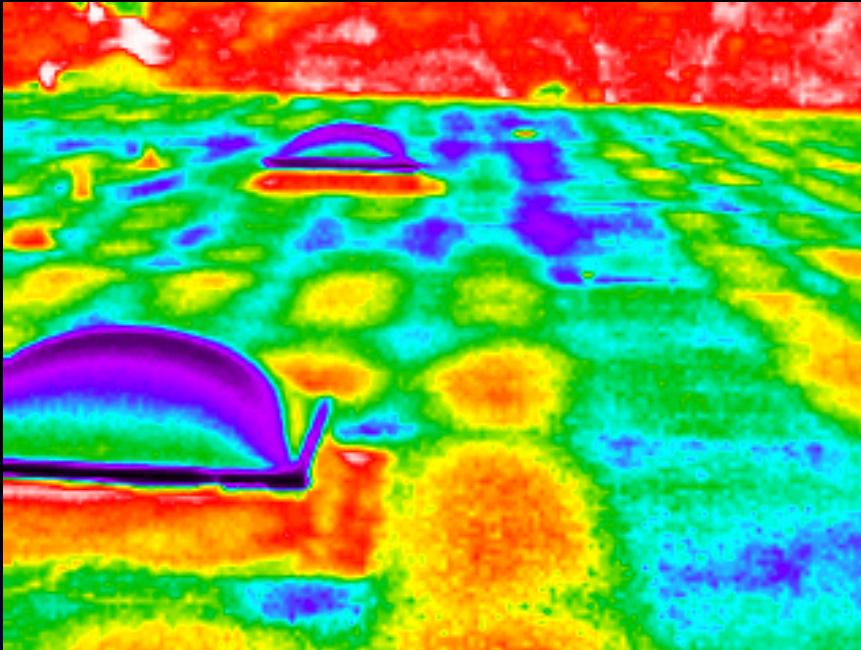
From the looks of this image it appears that the roof being surveyed has a significant amount of wet insulation; red and yellow outlined areas.

Yet in reality, there was no wet insulation throughout the entire roof.

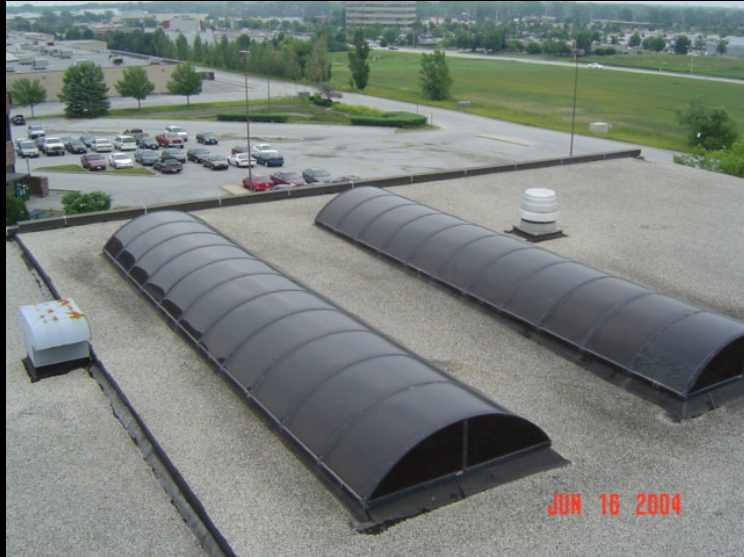
This roof didn't leak

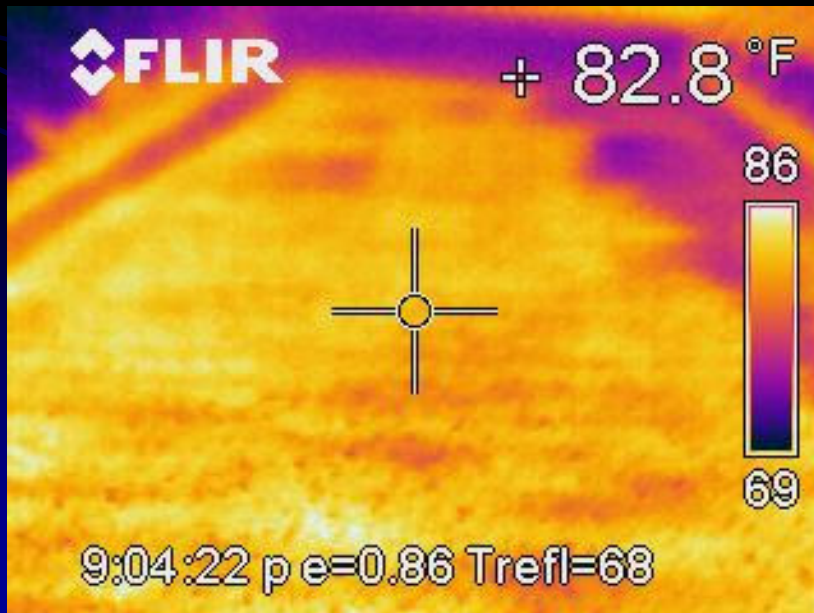
The roof scan discovered the roof was saturated and didn't leak because of a 2 ply vapor barrier.

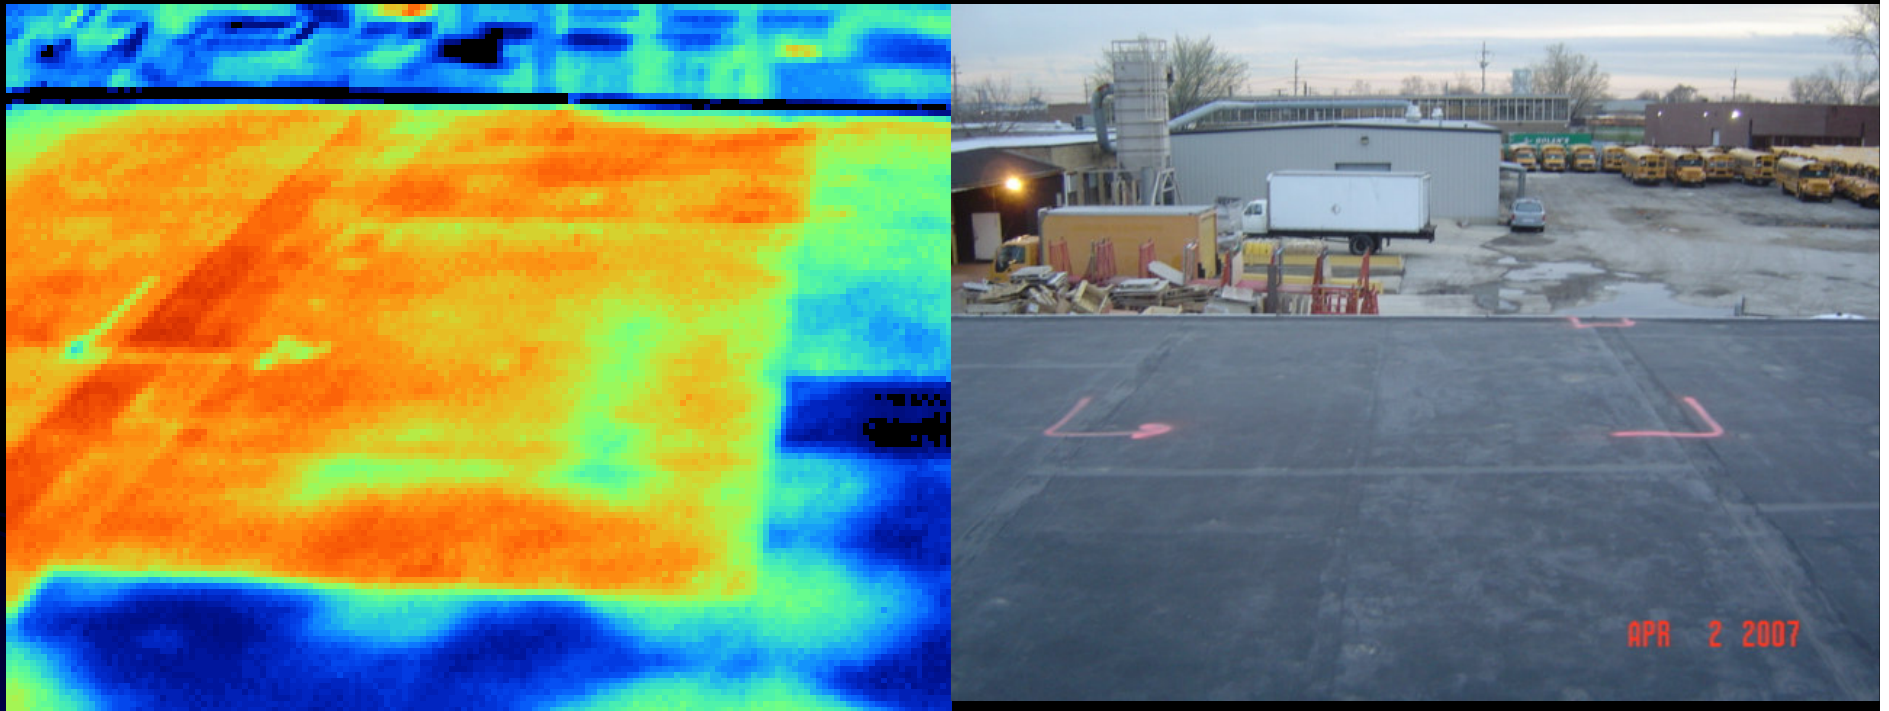
Roofing

The extent of wet insulation is clearly evident in this image. This is fiberboard insulation under an EPDM membrane.
