Infrared Thermography and The Building Envelope

Regardless of the building type involved, infrared thermography can provide remarkable nondestructive information about construction details and building performance.

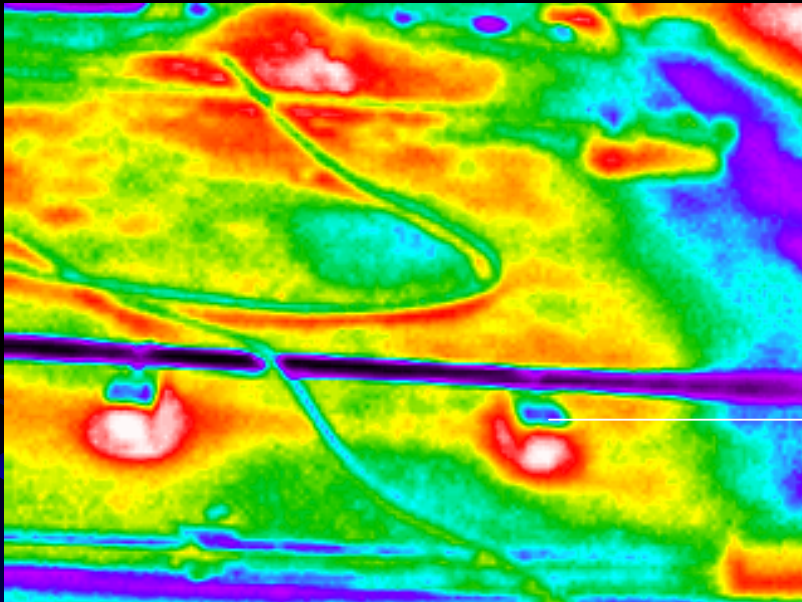
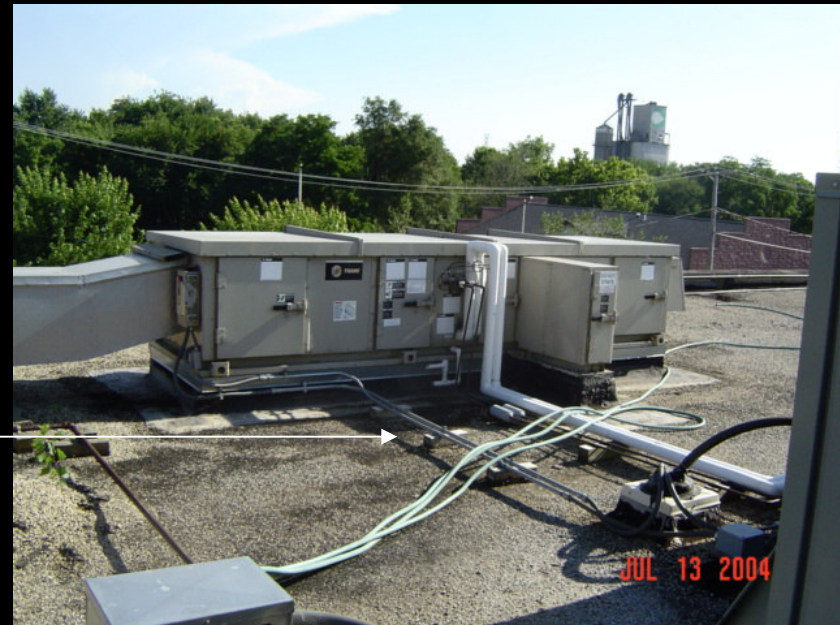
Roof leaks caused by improper
pipe supports

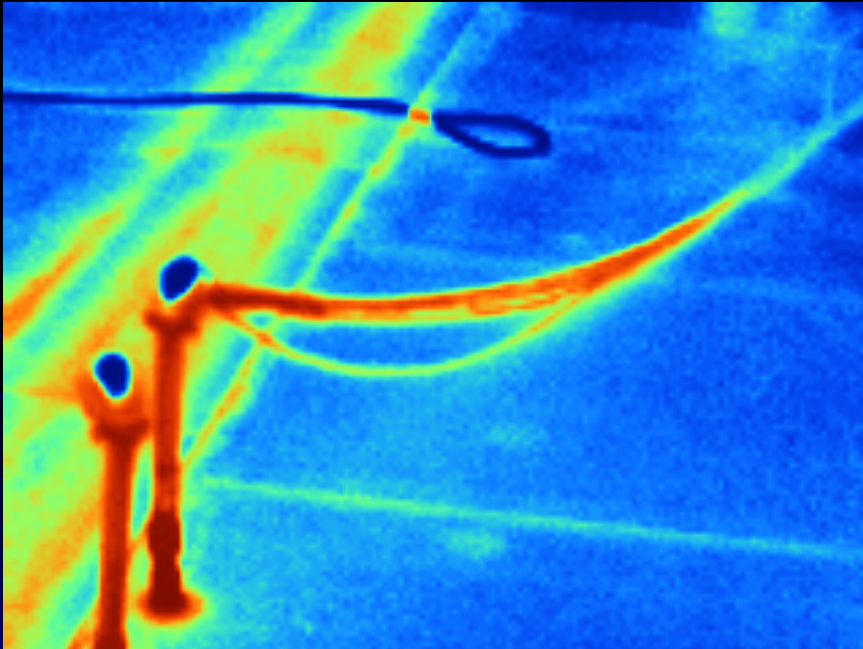
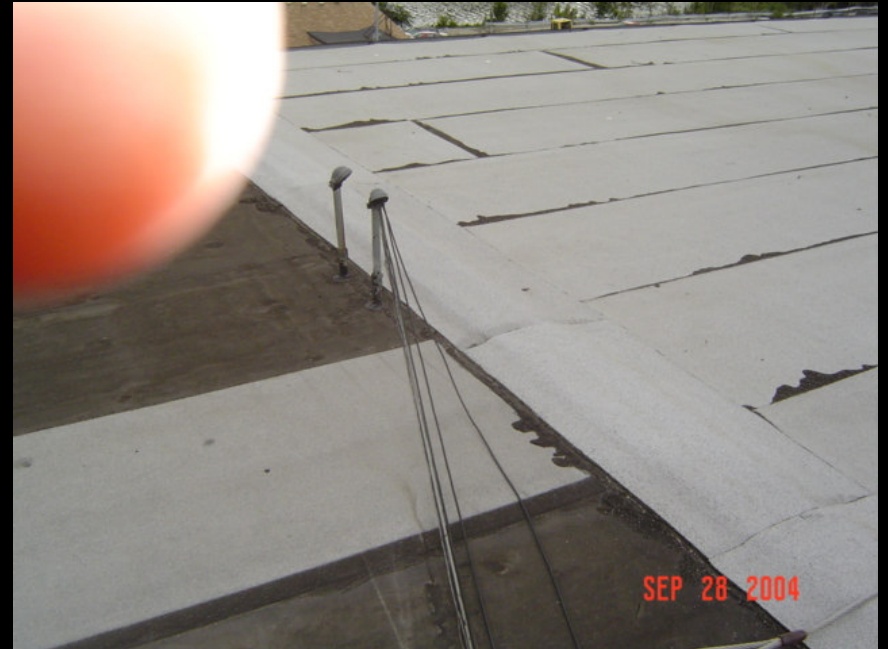
Leaking Control Joint

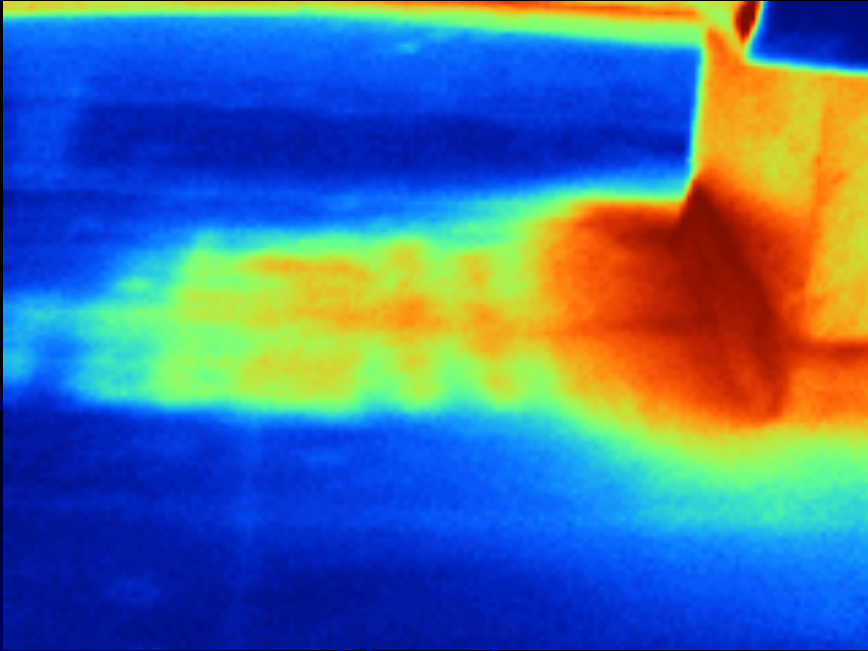
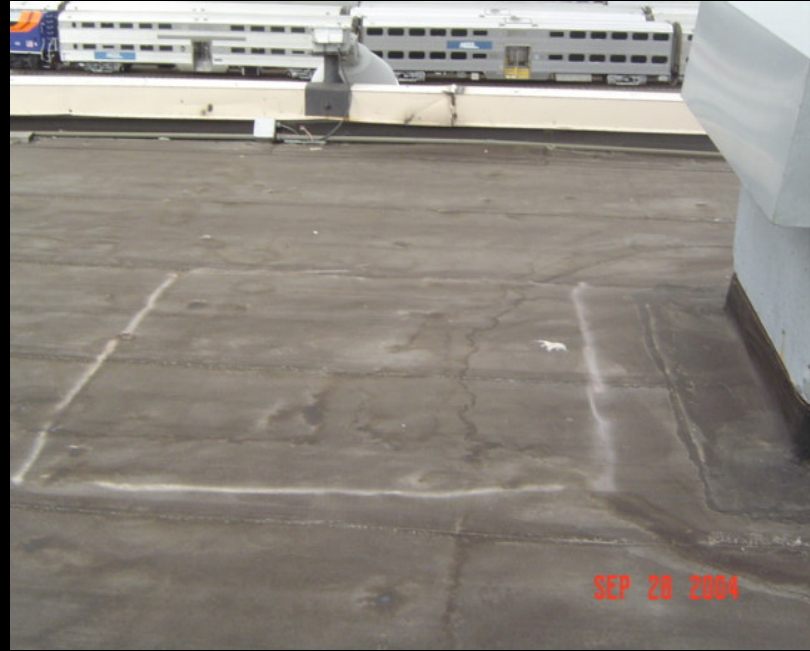
Roof Curb Leak

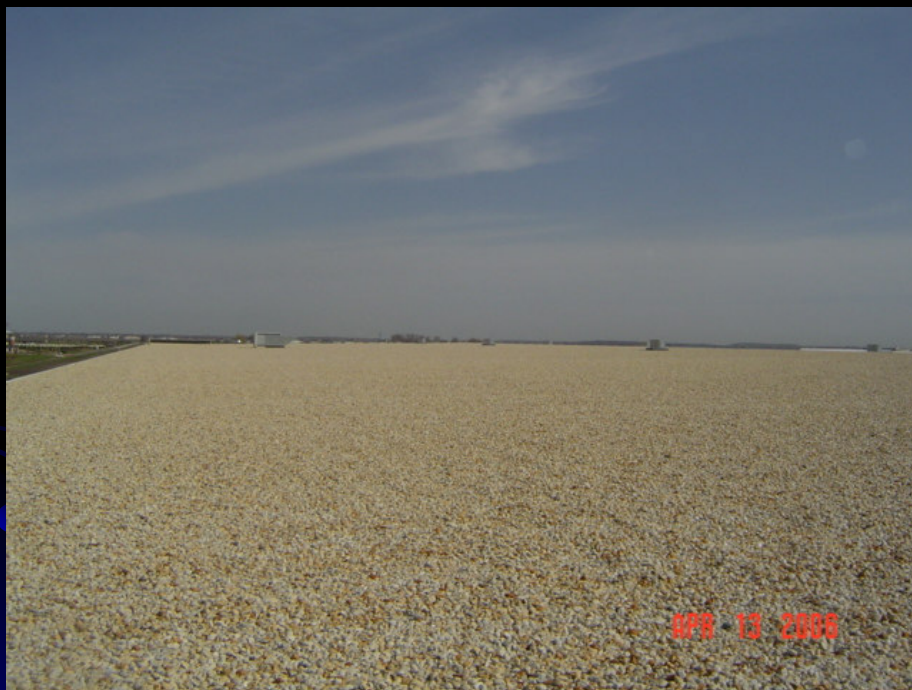
Ballasted EPDM

Some Roofs Are Difficult To Survey

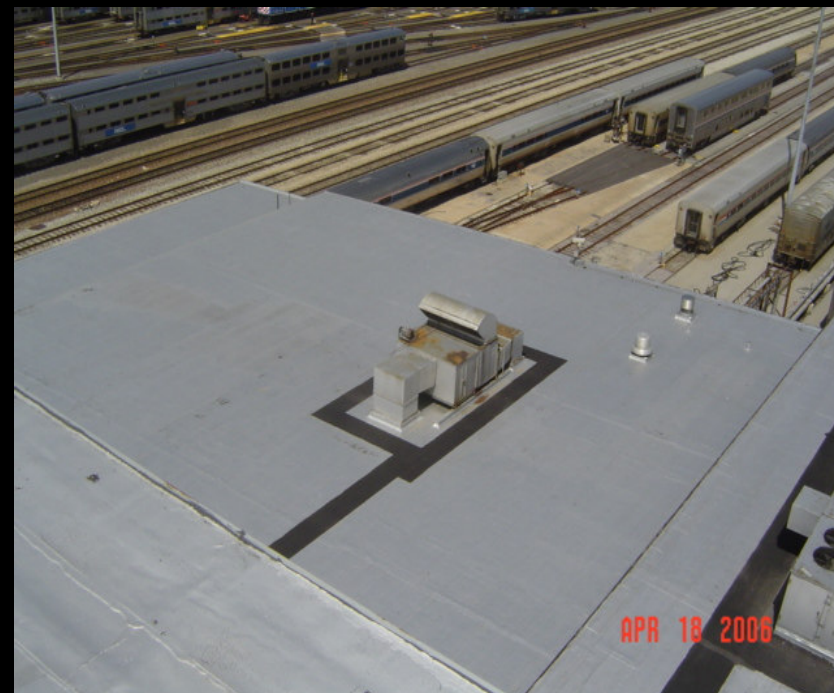
Coated Modified Bitumen

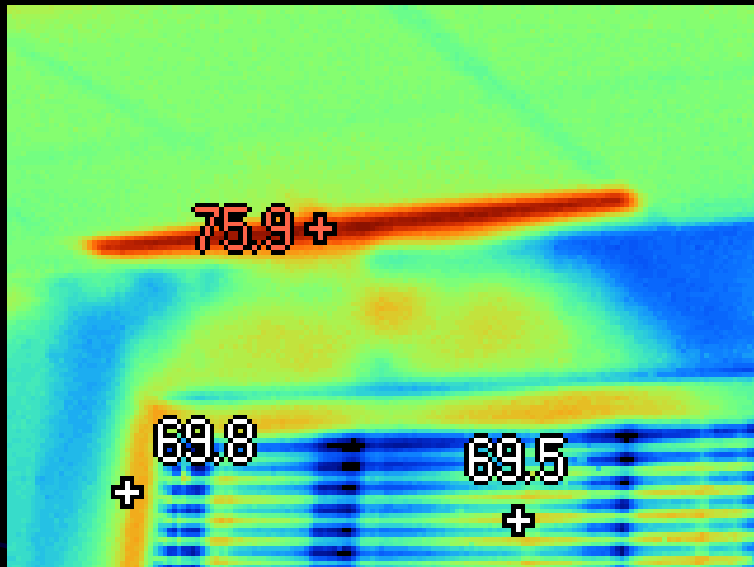
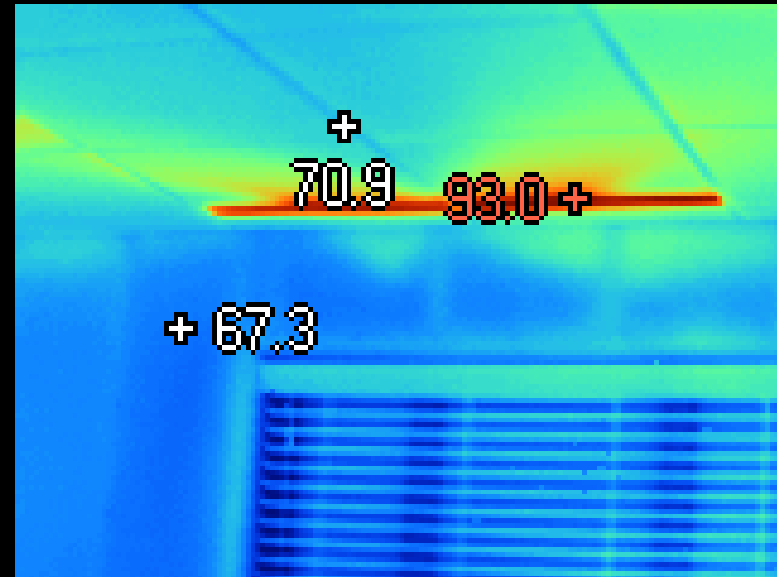
The air flow in the image on the left is good.

There is very little air movement in the image at the right.

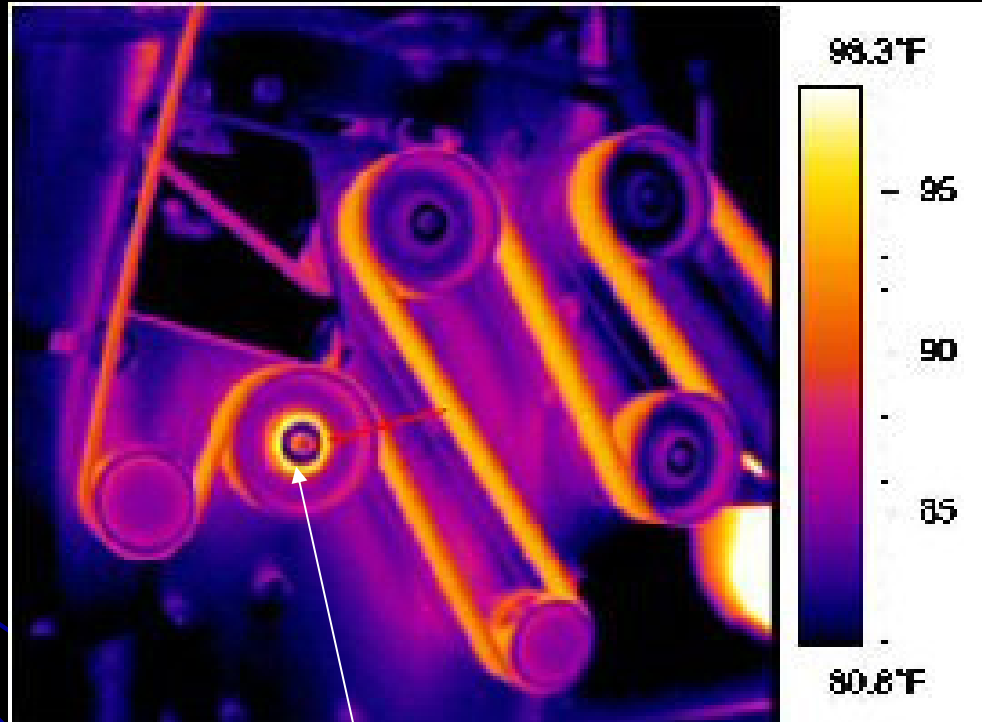
A worn bearing could shut this equipment down

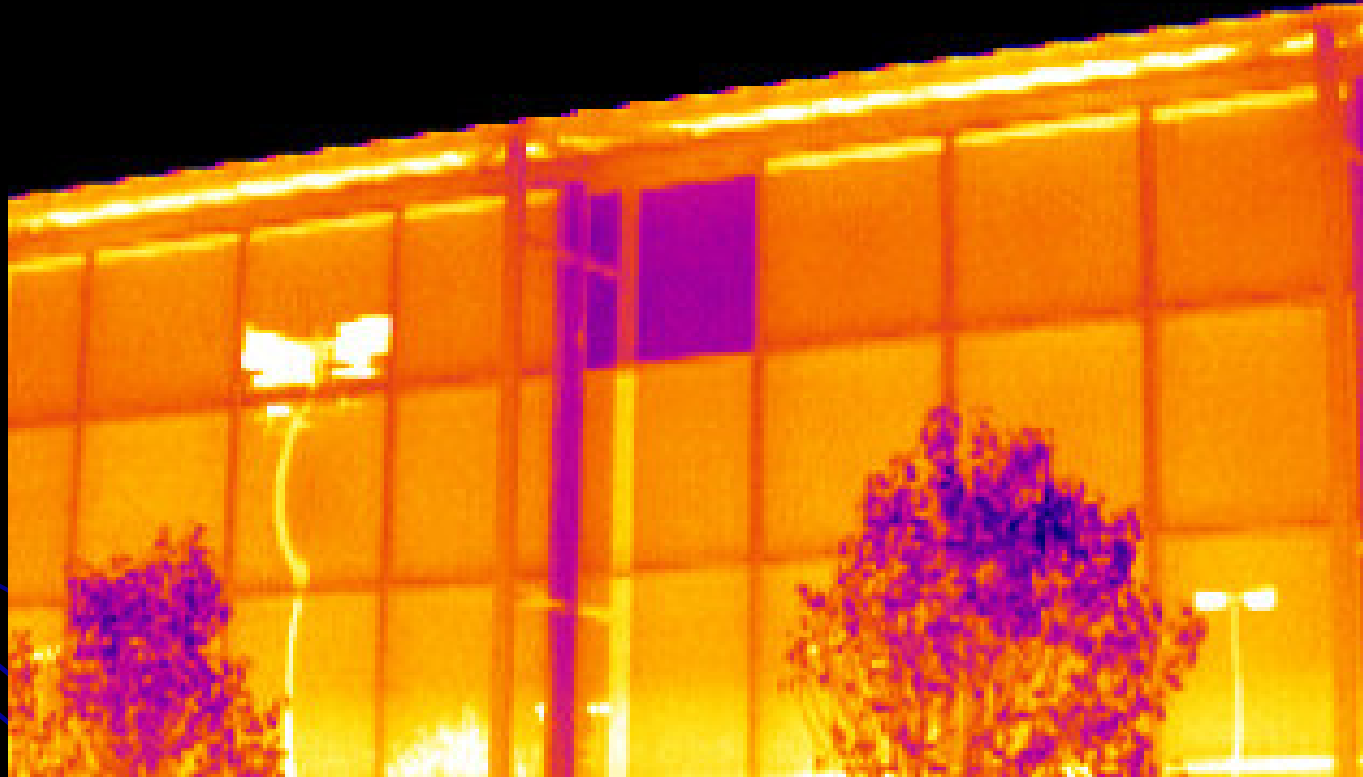
Double Pane Sample VS: Single Pane Glass
